# PHASE 1 ENVIRONMENTAL SITE ASSESSMENT AND HAZARDOUS MATERIALS SURVEY

Seattle Air Corporation site  
8535 Perimeter Road South  
Seattle, Washington 98108

Prepared for: King County Department of Construction and Facilities Management  
Property Services Division  
7233 Perimeter Road South  
Seattle, Washington 98108

January 20, 1999

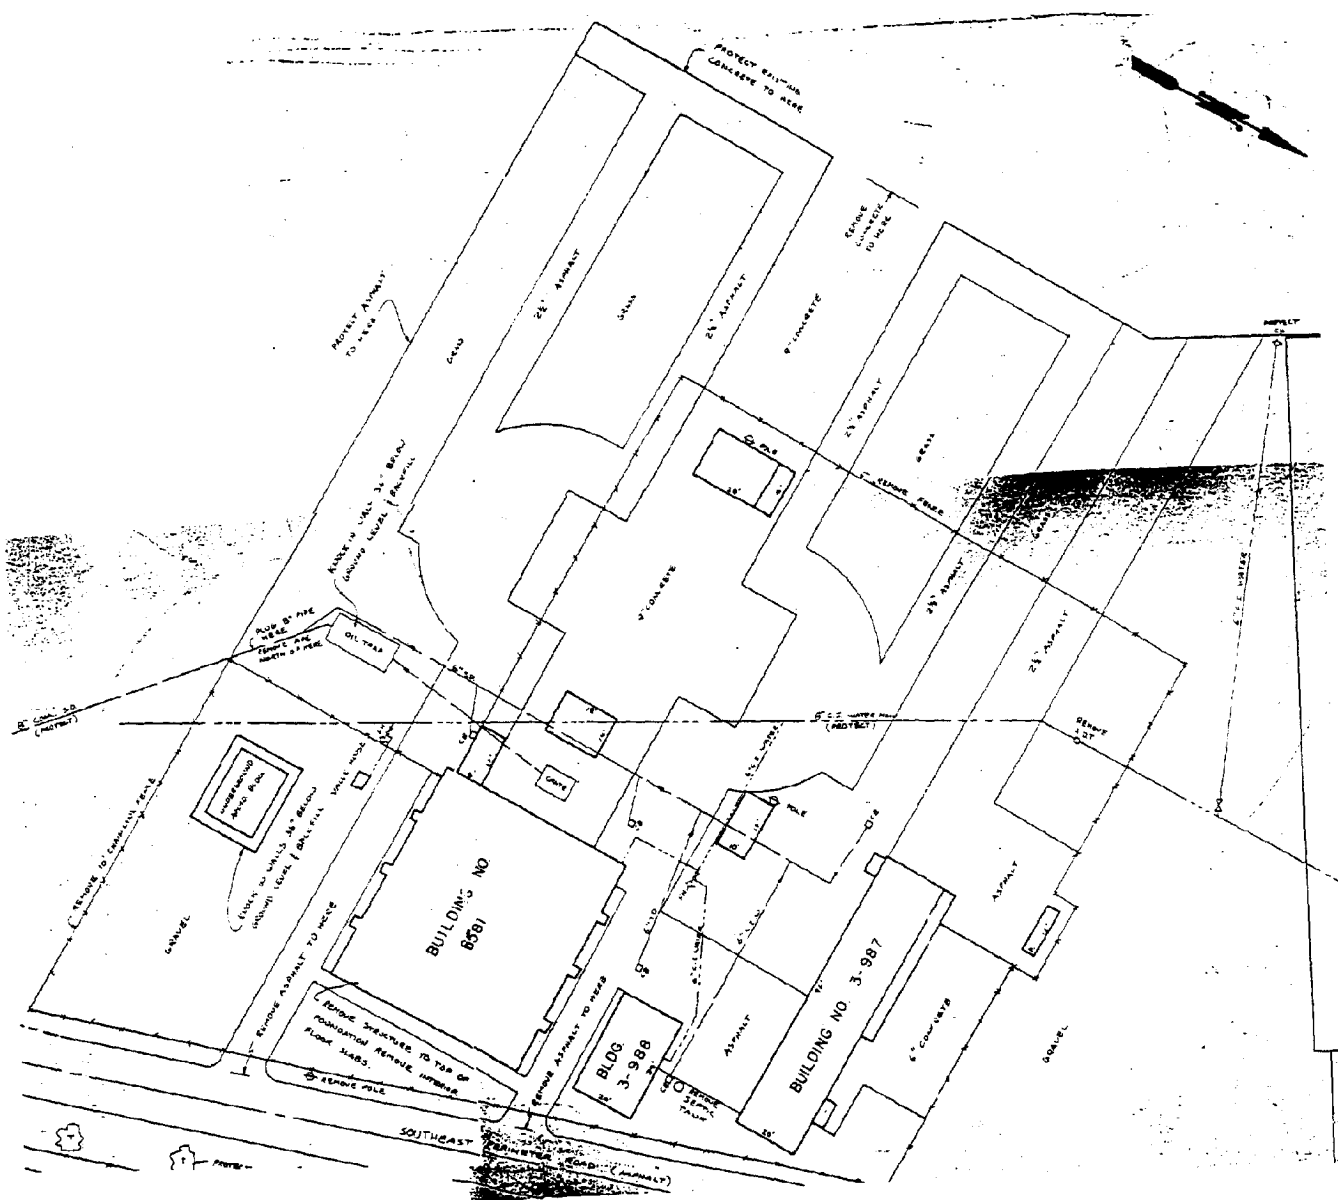
Figure 3. Historic site plan.

Historic site plans maintained by King County dated May 2, 1972 indicate there were at least 3 buildings previously onsite (Figure 3). These structures are numbered 3-987, 3-988 and 8581, and correspond directly to the structures noted in the 1966 Kroll map discussed above with the exception of building number 8581 which was labeled 3-989 (see Section 2.3.1). Also noted onsite was an underground ammunition building, and an oil trap (see Figure 3). Notes on the site plan indicate the ammunition building and the oil trap were abandoned in place by knocking down the walls 36 inches below ground surface and backfilling the area. There was no obvious evidence of these previous structures during the time of the site reconnaissance.
